ASSESSMENT OF DAM SAFETY OF COAL COMBUSTION SURFACE IMPOUNDMENTS – FINAL REPORT

**FirstEnergy Corp
Albright Power Station
Albright, West Virginia**

Prepared for
*U.S. Environmental
Protection Agency
Washington, D.C.*

December 2013
Revised April 2014

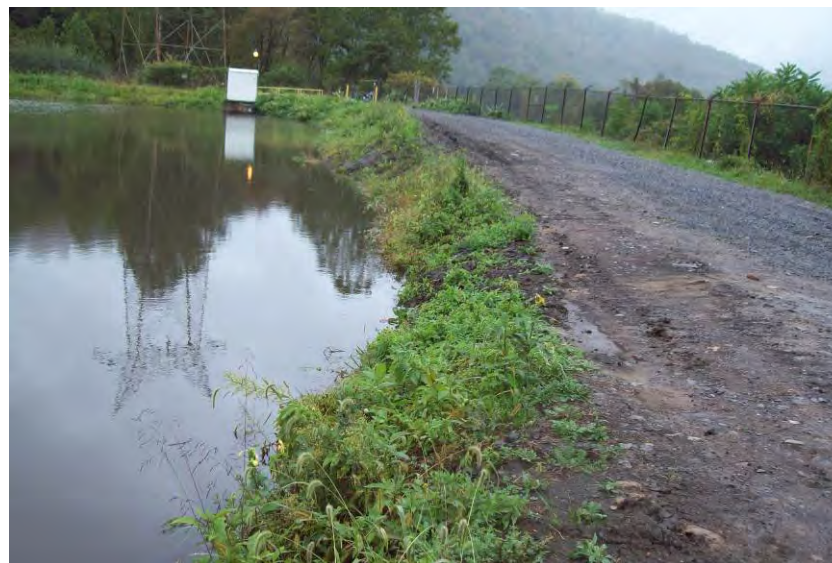
Photo 2: East embankment interior slope, looking northwest. Note vegetation on slope.

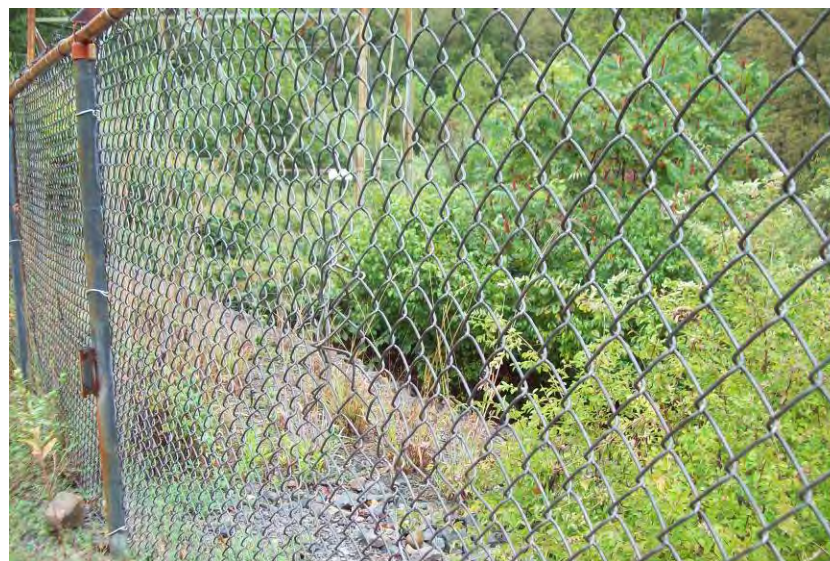
Trees and dense vegetation observed on the northeast embankment, exterior slope of the North Lagoon, adjacent to the Cheat River, should be removed and the embankment slope restored to the original contours by placing structural fill and compacting, as recommended by a qualified professional engineer. After slope restoration, it is recommended to stabilize the exposed surface of the embankment with sod, hydro seeding, or riprap consisting of a heterogeneous mixture of irregular-shaped rocks placed over the compacted fill and a geotextile fabric. Regular maintenance activities should be performed at least twice a year or as conditions warrant from the spring to fall to control and limit growth of vegetation on the embankments.

Photo 10: North embankment exterior slope, looking west. Note typical vegetation and riprap.

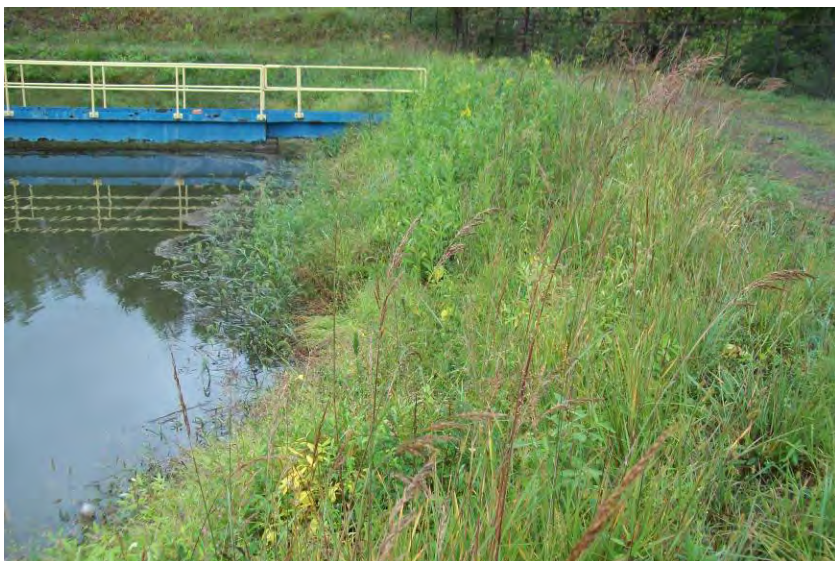
Photo 11: North embankment interior slope, looking southwest. Note typical vegetation and catwalk to outlet structure.

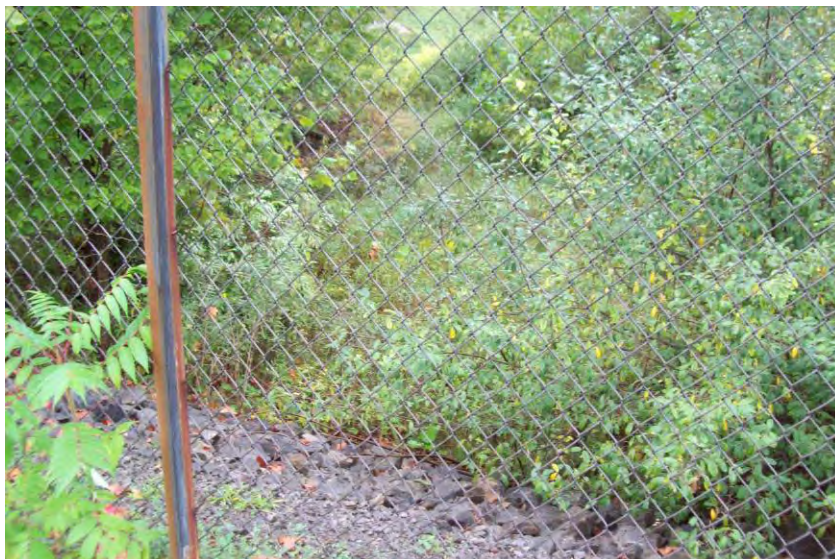
Photo 15: North embankment exterior slope, looking northwest. Note typical riprap and vegetation

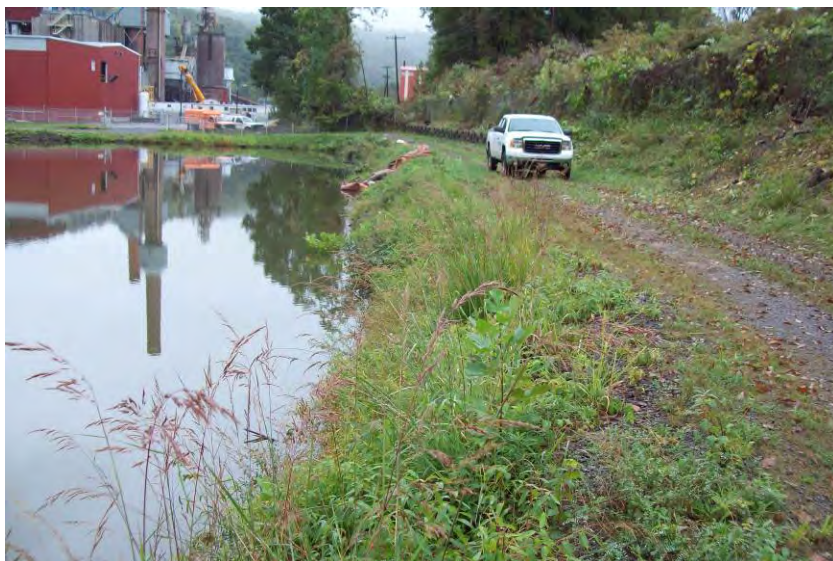
Photo 17: West embankment interior slope, looking southeast. Note typical vegetation.

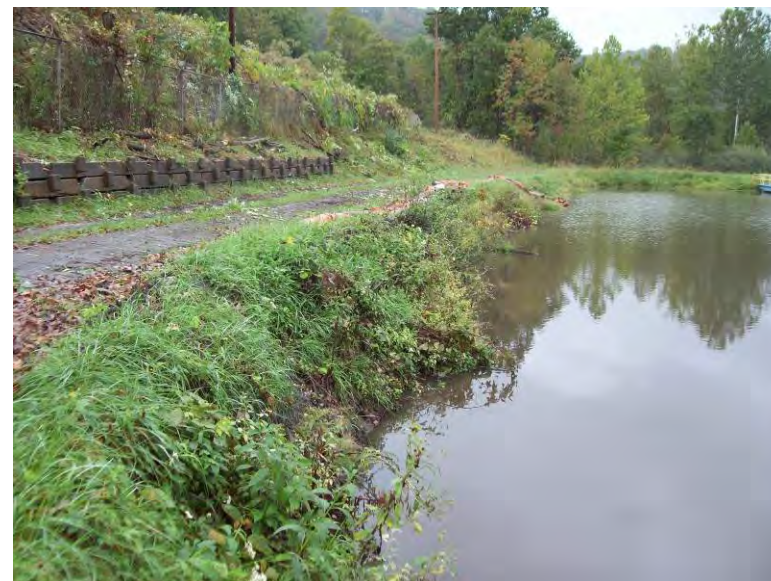
CDM Smith observed lateral movement of the retaining wall at the interior slope of the North Lagoon's south embankment. Lateral movement was not measured, but it appeared that the wall has moved several inches out of plumb. In CDM Smith's opinion, additional movement and/or collapse of the wall will not adversely impact the structural integrity of the North Lagoon, however First Energy Corp may find it advantageous to have a qualified professional engineer evaluate the stability of the wall and provide recommendations for remediation as appropriate. It is further suggested that FirstEnergy Corp may want to monitor wall movement prior to completion of the stability analyses.

Photo 22: West embankment interior slope, looking northwest. Note lateral movement of concrete crib retaining wall at interior slope

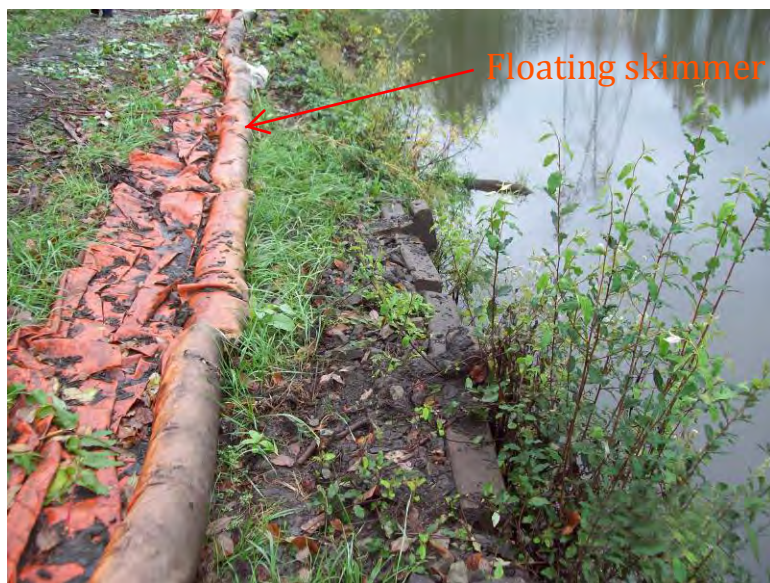
Photo 23: West embankment interior slope. Note lateral movement of concrete crib retaining wall at interior slope.

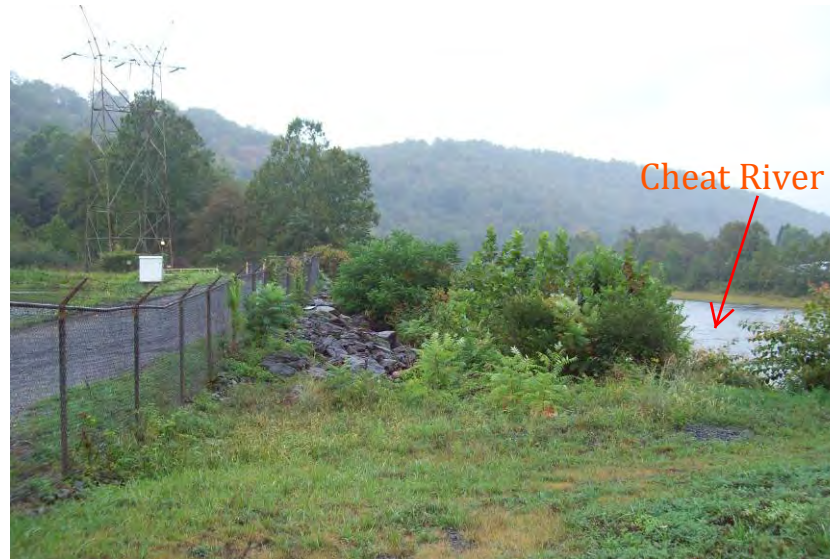
Photo 26: East embankment exterior slope, looking northwest. Note typical vegetation and riprap.

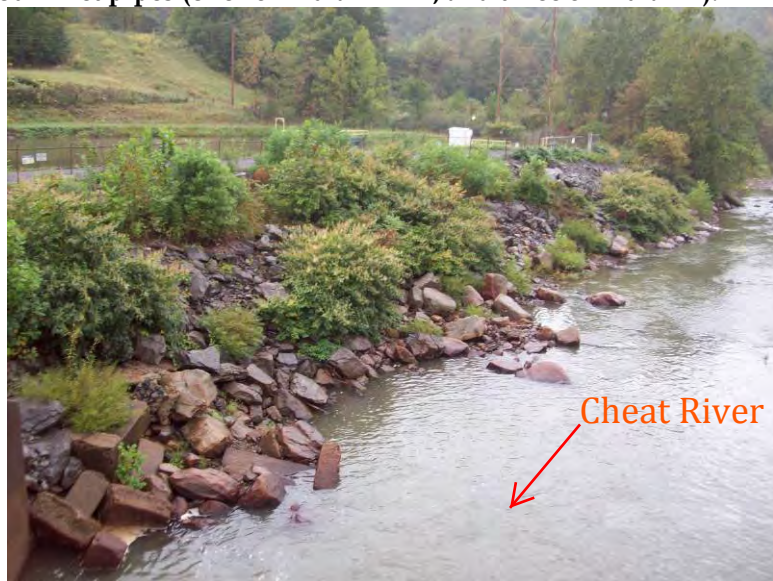
Photo 27: Bank of Cheat River, note typical vegetation and riprap.

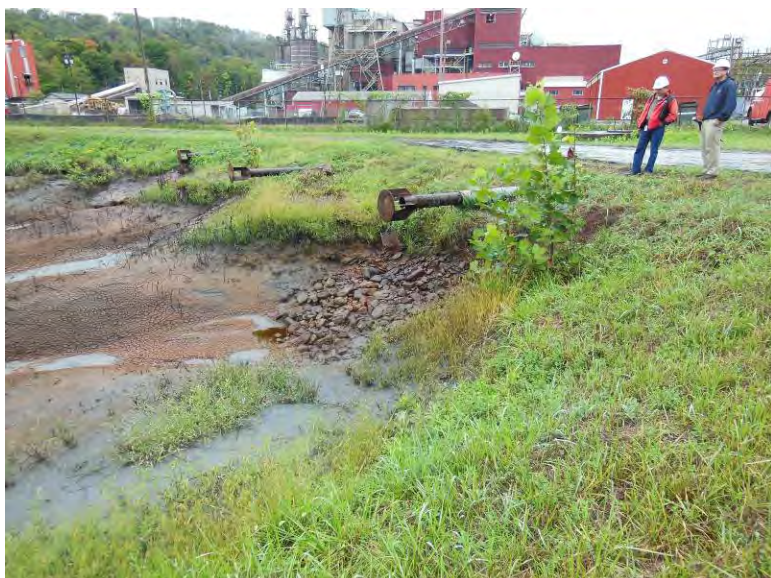
Areas of erosion were observed on the interior slopes of the north and west embankments of the South Lagoon near inlet pipes. To restore areas of erosion, it is recommended to place riprap to adjacent existing grade contours or place and compact structural fill, grade to adjacent existing contours, and apply grass seed.

Photo 30: North embankment interior slope, looking northwest. Note inlet pipes.

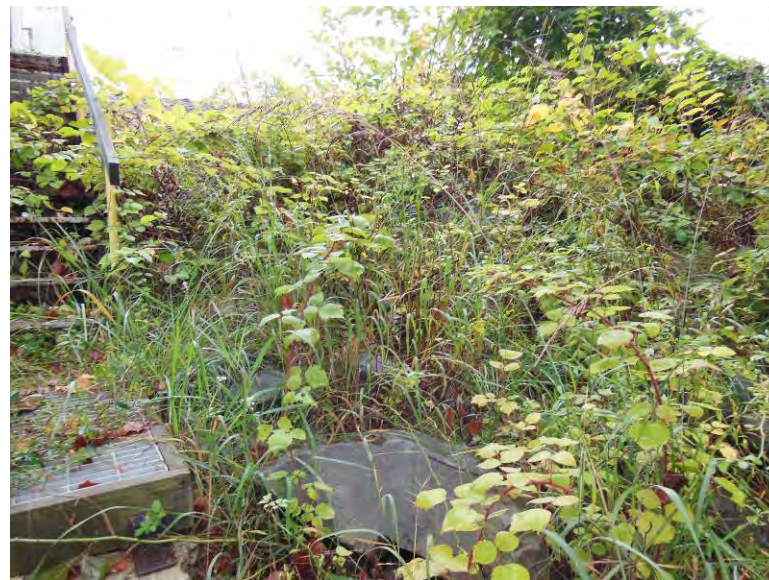
Photo 59: Stairs to outfall, looking northwest. Note vegetation.

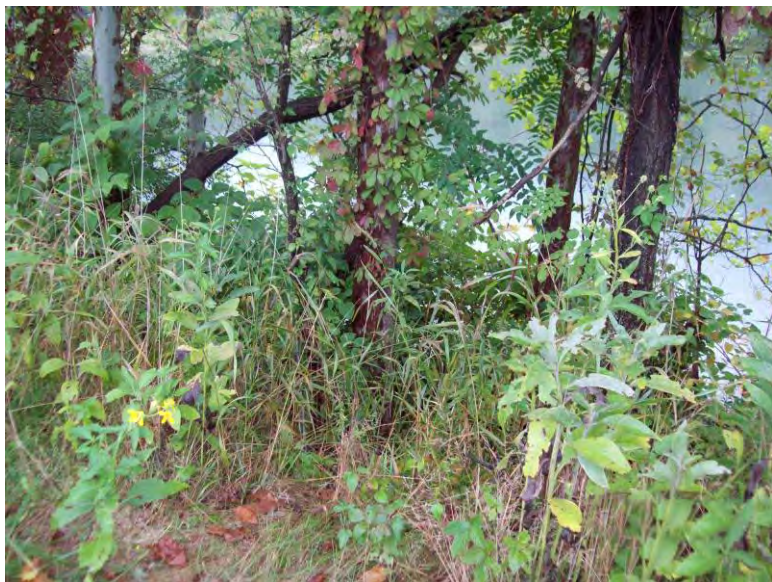
Photo 62: View of typical vegetation, along Cheat River, east of the South Lagoon looking northeast.
